Ohio State Highway Patrol

Reconstruction Report

Crash Report #47-0710-47 Boston Rd. 7/10th miles east of Boone Rd. Columbia Township / Lorain County

CRASH INFORMATION

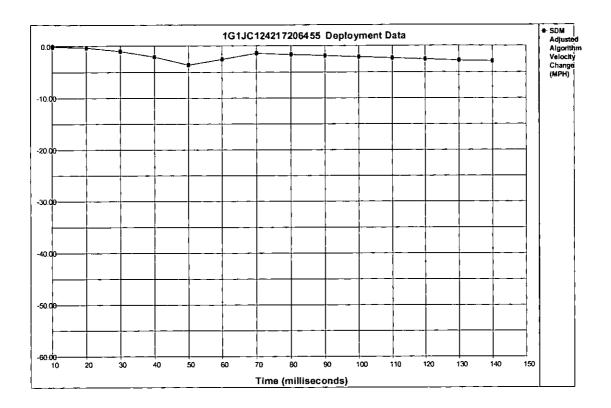
The EDR had recorded both a "Deployment" and "Deployment-Level" event. Based upon my analysis of the crash scene, I determined the first event to have been triggered by the front of the Chevrolet impacting the roadway at "touch down." The speed at "touch down" appeared to have been 59 miles per hour. The take-off speed was reported at time -2 at 65 miles per hour. In the three seconds before touchdown, the vehicle accelerates slightly from 64 to 66 miles per hour before take-off at 65 miles per hour.

Seconds Before AE	Vehicle Speed (MPH)	Engine Speed (RPM)	PercentThrottle		
	64	2624	38		
-4	65	2304	49		
-3	66	2304	44		
-2	65	2240	0		
-1	59	2176	0

Time (milliseconds)	10	20	30	40	50	60	70	80	90	100	110	120	130	140	150
Adjusted Algorithm Velocity Change	-0.04	-0.26	-0.92	-2.02	-3.56	-2.46	-1.36	-1.58	-1,80	-2.02	-2.24	-2.46	-2.68	-2.90	N/A

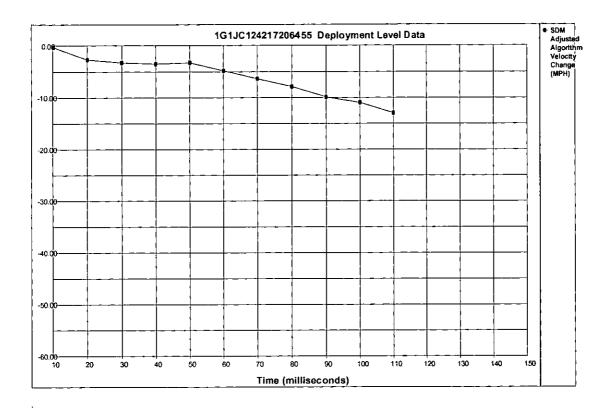
The second event likely takes place when the Chevrolet impacts the tree. There were two seconds of overlap between the two events, leaving three seconds of "post landing" data. Speed is reported at 61, 59, and 66 before triggering the Deployment-Level Event.

Seconds Before AE	Vehicle Speed (MPH)	Engine Speed (RPM)	Percent Throttle		
-5	65	2240	0		
-4	59	2176	0		
-3	61	2304	16		
-2	58	2240	13		
-1	66	4352	100

Time (milliseconds)	10	20	30	40	50	60	70	80	90	100	110	120	130	140	150
Adjusted Algorithm Velocity Change	-0.20	-2.61	-3.27	-3.49	-3.27	-4.81	-6.34	-7.88	-9.86	-10.95	-12.93	N/A	N/A	N/A	N/A
